Modine Technical Service Bulletin

Subject: Safety issue when separated combustion gas-fired heaters are used in conjunction with a failed vent system

Date: January 2019

Affected Models: Separated combustion unit models including but not limited to: PSH/BSH, HDS/HDC, PTS/BTS, PTC/BTC, DFS, DBS, DCS, IFS, IBS, ICS.

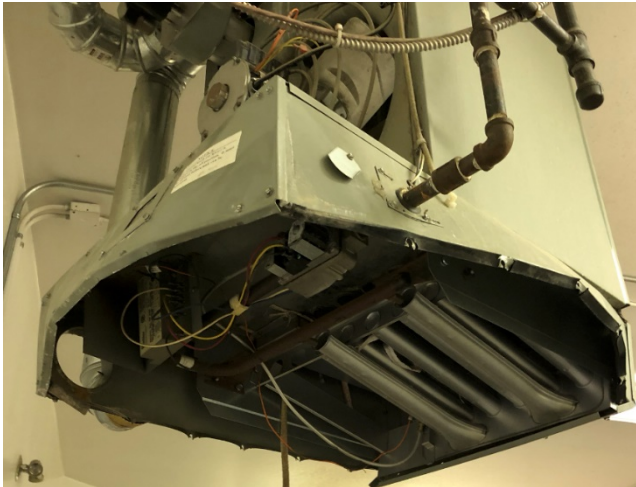
Figure 1: Damaged unit heater Potentially caused by failed Vent System

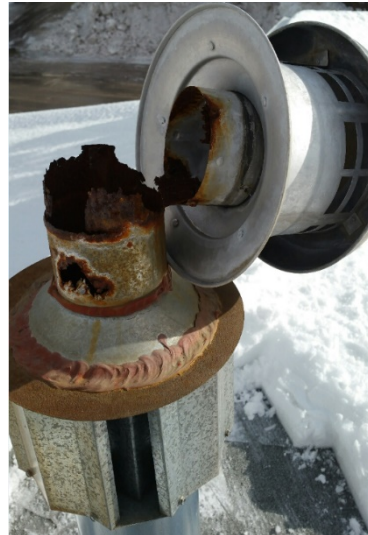
Figure 2: Failed Concentric Vent System

Modine has extensively reviewed documentation from numerous sites. Among the items common to these sites is a concentric vent where the product of combustion (exhaust) was allowed to recirculate back into the combustion air pipe (fresh air).

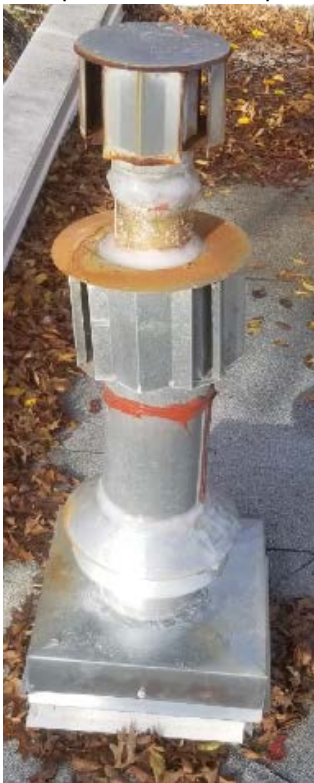
Figure 3: Visual Inspection of Vent Pipe is **NOT Sufficient**.

Inspections must be performed on all vent systems to make sure they are in proper working order. Figure 3 shows that visual inspection of concentric vents is not adequate to determine if the vent is working properly. Figure 4 shows the vent system from Figure 3 upon further inspection. Vent caps must be removed to inspect the inner pipe and ensure it has no breaches. Two-pipe systems should also be reviewed to ensure recirculation of products of combustion is not possible. Preventive maintenance is required on all gas fired appliances. At least annual inspection of vents on all gas appliances is best practice.
